FAILURE ANALYSIS OF BALL MILL GEARS

Chris Meimaris, Managing Director, EAnD, Brisbane, QLD, Australia
 Michael Duncan, Associate, EAnD, Brisbane, QLD, Australia
 Leigh Cox, Engineering Manager, Cadia Hill Gold Mine, NSW, Australia

ABSTRACT

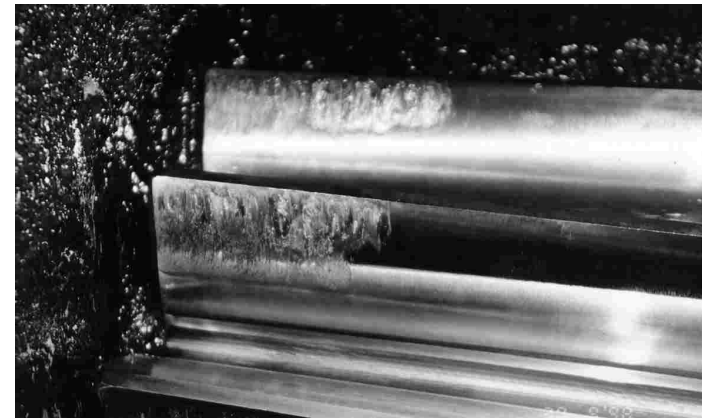
Fig. 1 – Pinion Tooth Damage

The damage to the gears was very localised. It was limited to a region within 100 mm of the ends of the gear teeth. The damage was typical of scoring caused by the metal-to-metal contact due to lubrication breakdown. However, the lubricants used on the gears had been used in the past on other, more highly loaded gear sets by the Cadia engineering staff without any problem. It was necessary to determine why the lubricant broke down so that further damage could be avoided. Some of the possible causes considered during the root cause analysis are presented below.

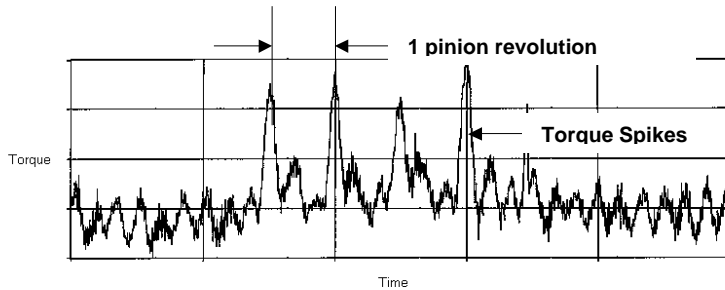
Only one set of torsional tests showed any evidence of unsteady torsional behaviour. This set of data was from a test that was performed approximately two weeks after the gear damage was first observed. The torsional signal recorded during these tests exhibited spikes at random times as shown in Figure 2. The signal showed an increase in torque once per revolution of the pinion for a short time and then the torque signal returned to steady state. This behaviour was not noticed in any of the tests taken after this time. It is possible that these torque spikes may have been evidence that metal was being removed from the gears during operation.

Fig. 2 –Spikes in Pinion Torsional Vibration Signal

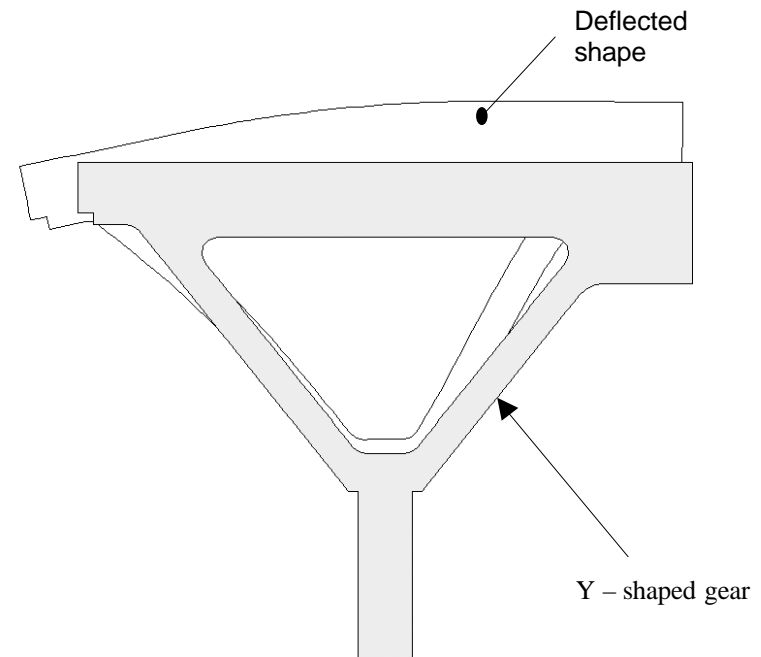
The approximate girth gear profile is shown in Figure 3 page II-91. The gear has a Y-shaped supporting structure and the cope end of the gear is almost twice as thick as the drag end. When a pinion applies a torque to the gear, the differential stiffness of the gear will result in a higher load being taken by the ends of the gear opposite the webs due to the greater stiffness of the gear in this region. Furthermore, the cope end of the gear will attract more load than the drag side, as the cope side is the stiffer. Therefore, if a uniform stiffness pinion was used to apply load to the gear face, the contact load would be greatest near the web on the cope side of the gear. Temperature would also be greatest at that end and the gears would appear to be out of alignment even if their mechanical alignment was perfect.

Fig. 3 – Gear Cross Section and Deflected Shape due to Uniform Thermal Input

A simple analysis of the girth gears was devised to assess the thermal behaviour of the girth gears. The gear was considered as an axisymmetric structure as shown in Figure 3 page II-91. A *uniform* thermal energy input was applied across the face of the gear. The deflected shape of the gear determined from the model is also shown in Figure 3. It can be seen that the cope end of the gear deflects more than the drag end. This result was sufficient to show that the assumption in item (c) in the previous section was correct, ie, that the girth gear would preferentially expand at the cope end.

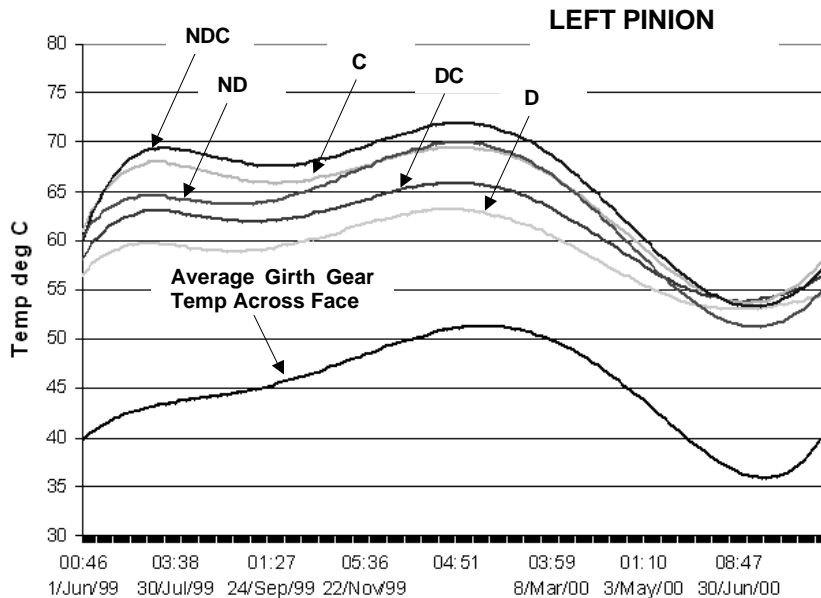
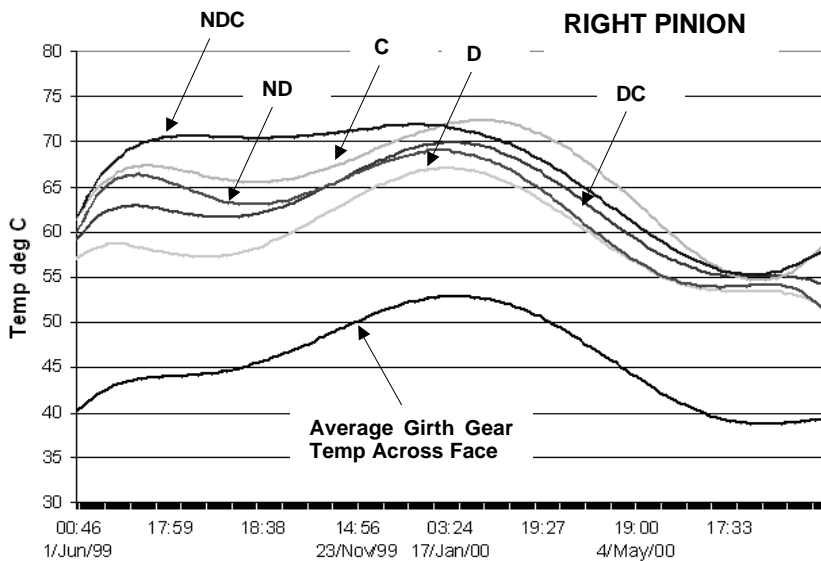
Pinion temperature profiles over a one-year period from July 99 were interrogated to determine if there was any evidence of preferential load in the gear sets. The results obtained from Ball Mill 1 are shown in Figure 4 p. II-92. In this figure, the temperatures across the face of the pinions at five discrete locations are plotted against time. It can be seen that both pinions showed consistently higher temperatures on the cope end corresponding to the non-drive end of the girth gear. The maximum

temperature usually occurred at the NDC location inboard of the damaged area of the pinions. If the differential stiffness theory is correct, then it would be expected that the maximum temperature would occur at the ND location of the pinion, ie, at the end of the tooth where the damage occurred. However, the temperature records used in generating Figure 4 were all recorded *after* the damage to the gears had occurred. Material had been removed from the gears both by the damage and by the finishing of the gears performed as part of the pinion repairs. Thus, the contact force at the damaged sections of the pinions would be lower than it would have been prior to the damage having occurred. This explains why the maximum temperature generally occurs inboard from the non-drive end for Ball Mill 1. A similar analysis of gear temperatures was performed for Ball Mill 2. Results were almost identical except that highest temperatures were at the DC location inboard of the gear cope.

Fig. 4 – Mill Pinion Temperatures Over 12 Months

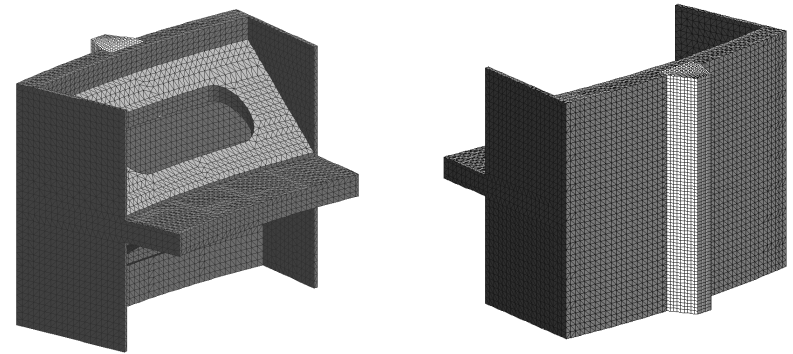
The analysis of the contact stresses was more difficult. Modelling the entire girth gear, the pinions, the interaction between the gear and pinion teeth and the supporting structures was considered too expensive, thus an idealised analysis was developed. The model used for the analysis considered only a single sector of the girth gear between the web gussets as shown in Figure 5. The sector comprised of a the gear bolting flange, the two “Y” webs and lightening holes, the gussets either side of the lightening holes and an idealized tooth at the centre of the sector. The different thickness in the gear due to the casting cope and drag were included. The model was constrained to simulate the contact of a pinion with the tooth on the gear taking care not to violate the rules of 3D-elasticity. Bending stiffness of the pinion between its bearings was neglected for this analysis.

Fig. 5 – Model of Gear Sector

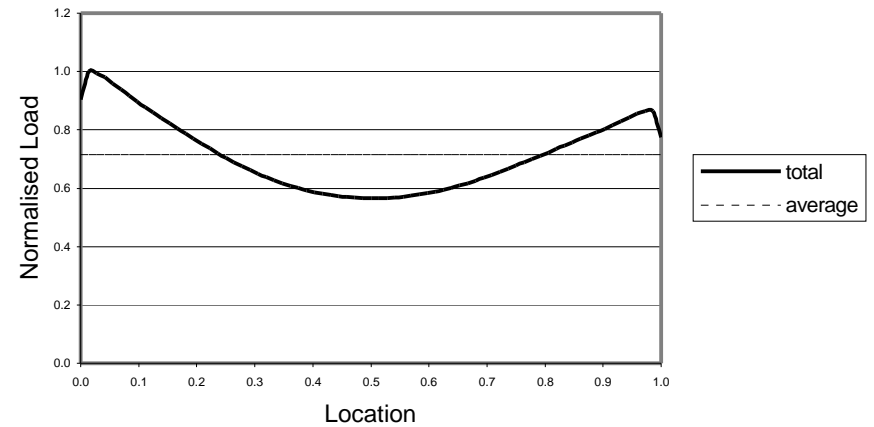
Results: The calculated contact force distributions as a function of location across the tooth face *for no heat input* is shown in Figure 6; results have been normalised with respect to the maximum calculated contact stress. The full line curve represents the contact stress in the gear tooth and the dashed curve represents the average load on the tooth (the integral of the total curve divided by the width of the tooth). The load at the cope side is 13% greater than the drag side load and the peak load is 39% greater than the average load. The results obtained from the model when heat input was included are shown in Figure 7. The total load on the cope side is 25% greater than the drag side load and the peak load is 44% greater than the average load.

The results in Figures 6 and 7 indicate that the additional thickness of the cope results in locally higher contact loads on the cope side. Furthermore, thermal expansion of the gear results in an increase in the load on the cope side the gear relative to the drag side. The *uniform* thermal energy input used in this analysis resulted in an increase in peak load from 139% to 144% of average tooth load at the cope end of the gear whereas the load at the drag end reduced from 86% to 81% of the mean load.

Fig. 6 – Normalised Load Distribution Without Heat Input

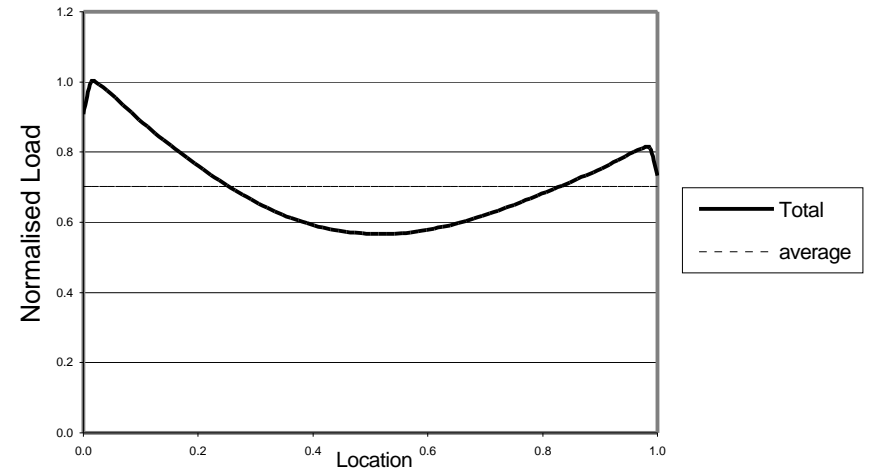
It is interesting to note that the contact force distributions in Figures 6 and 7 show a drop off in force near the ends of the tooth. Initially, this was thought to be a function of the constraints and idealisations used in the analysis. However, further analysis showed that the effect was due to a plane stress zone that extends into the gear face for a short distance from the free surfaces. Capturing the extent of this plane

Fig. 7 – Normalised Load Distribution With Heat Input
