EAnD's Engineers Solve Vibration Problems in the World's Largest Mill Drive.

SAG Mill Stator - Vibration Study

Root Cause Analysis 1: Vibration

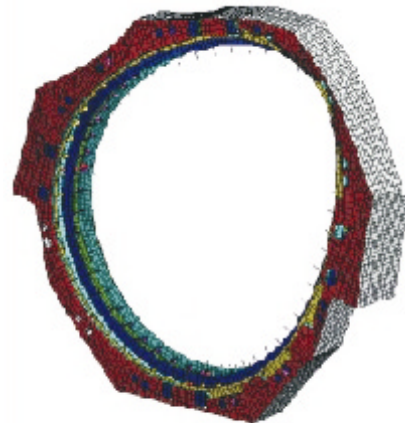
The result of the tests confirmed that the stator vibrated in its second mode. This explained why the temporary chocks at the bottom of the stator were effective in reducing the vibration – they effectively stiffened the stator thereby reducing the amplitude of the vibration. However, the vendor indicated that their design calculations had estimated the second mode frequency of the stator was almost twice the resonant frequency. This meant that more needed to be done to prove to everyone's satisfaction which component of the system was resonating, the foundation or the stator.

Second mode of vibration of the stator. The deflected shape (exaggerated) is identical to the mode measured on site.
Model developed by EAnD.
